**Department of Public Works
Water Resources Engineering
212 South Bond Street
Bel Air, MD 21014
(410) 638-3545**

Water Resources Engineering

Sunnyview Stream Restoration
0 100 200 400 Feet

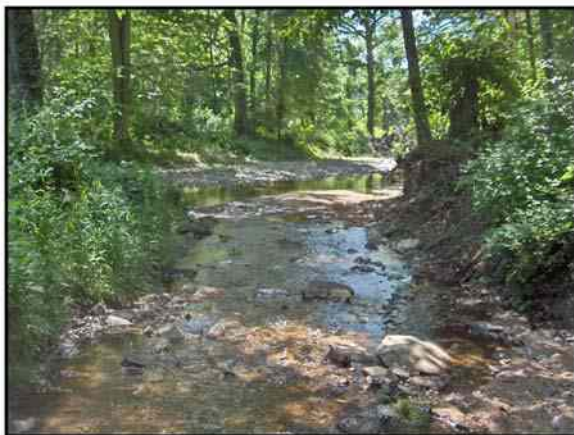
Photo 3 – Facing downstream along tributary toward Bynum Run confluence

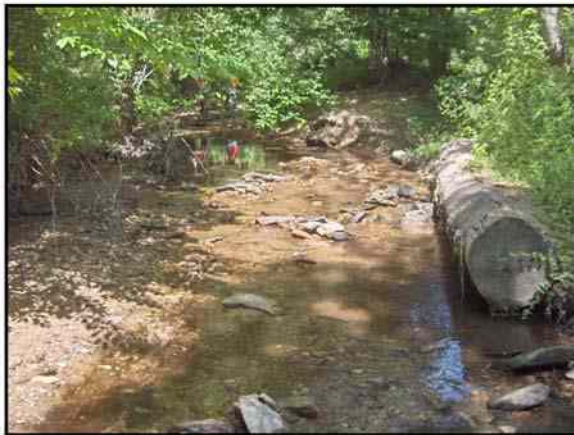
Photo 4 – Facing upstream toward the riffle at the downstream proposed work limits

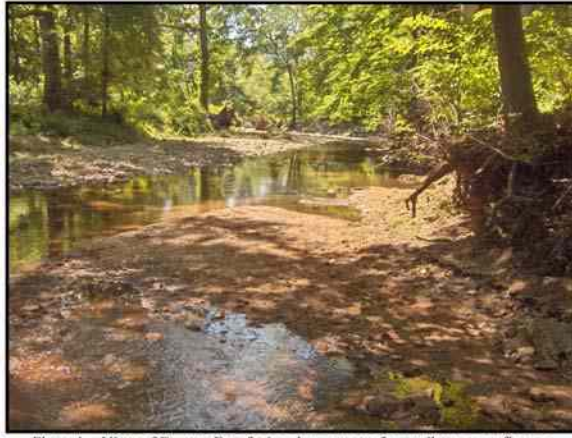
Photo 1 – View of Bynum Run facing downstream from tributary confluence

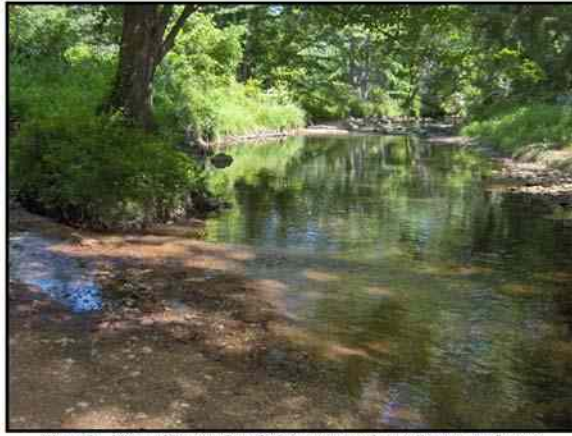
Photo 2 – View of Bynum Run facing upstream from tributary confluence

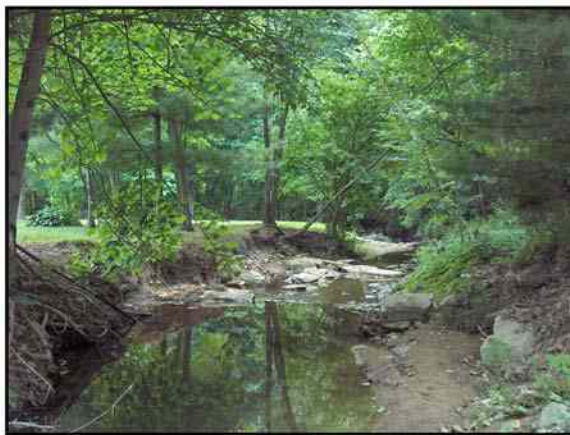
Photo 9 – View facing downstream at the Reach 1 and 2 interface

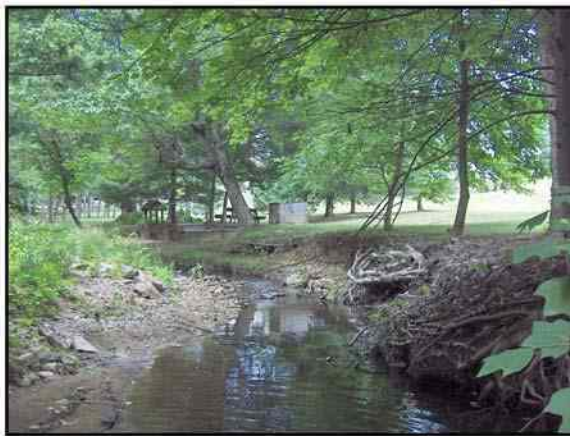
Photo 10 – View facing upstream from the Reach 1 and 2 interface

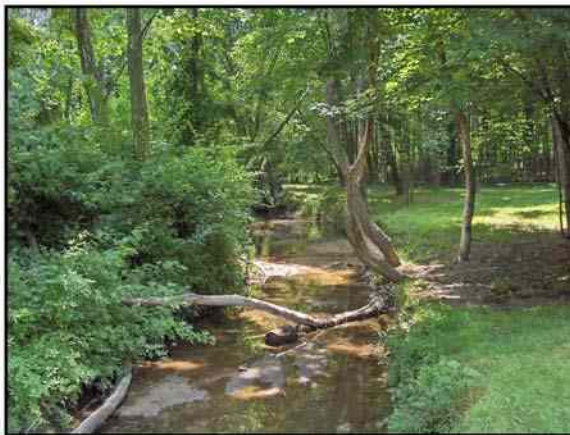
Photo 12 – Upstream view toward the sediment transport sampling buckets

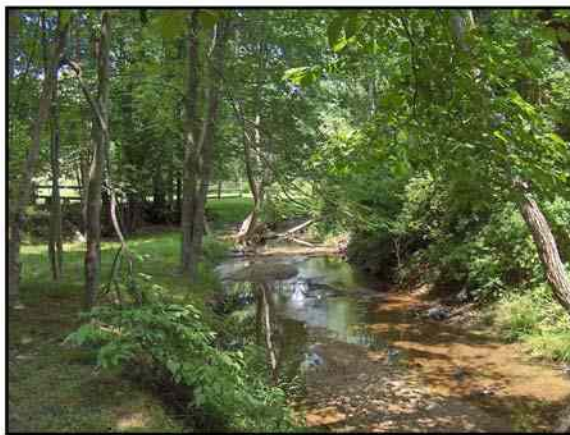
Photo 13 – Representative view (facing downstream) near the Reach 3 and 4 interface

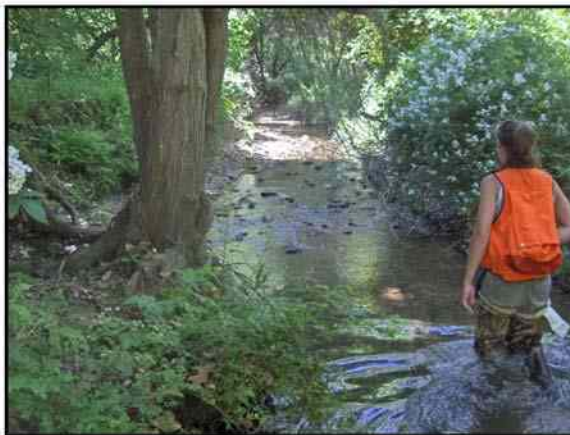
Photo 16 – Facing upstream toward the riffle at Option A of the upstream proposed work limits

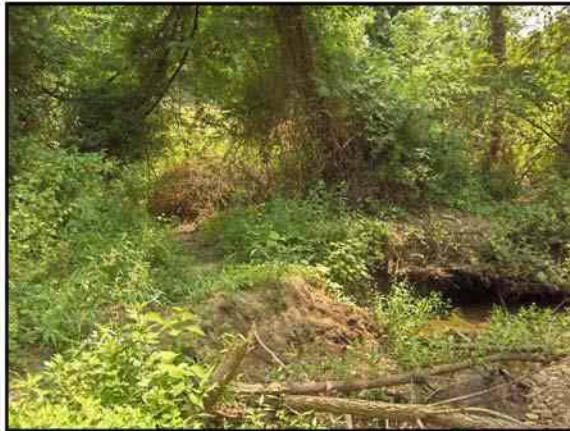
Photo 20 – Downstream view of a tight meander bend with toe scour and potential for development of a chute cut-off channel

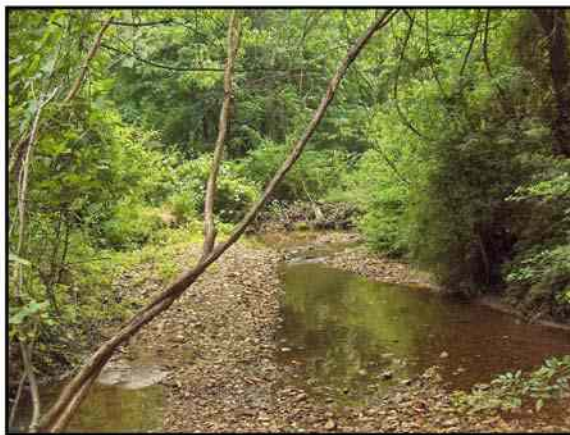
Photo 21 – Upstream view of a riffle feature at Option B of the upstream proposed work limits
